**Street Route Accessibility Audit
For
Blessington & District Forum**

September 2019

Accessibility Audit

BLESSINGTON MAIN STREET, CO WICKLOW

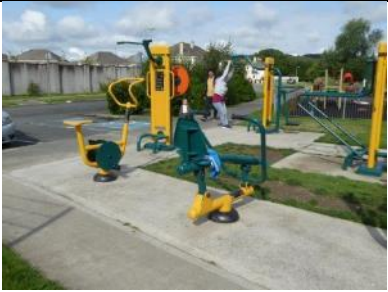
1.6	Outdoor gym	The outdoor gym and exercise equipment is an excellent addition to the playground area and much of the equipment is suitable for people of varying abilities. Despite signage indicating that certain items are usable by wheelchair users it was not clear that they were.

See 1.7 below	2

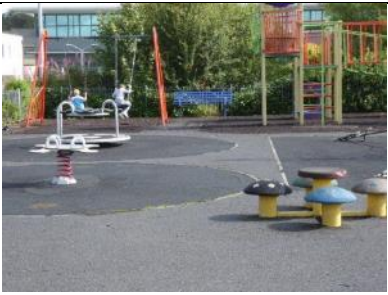
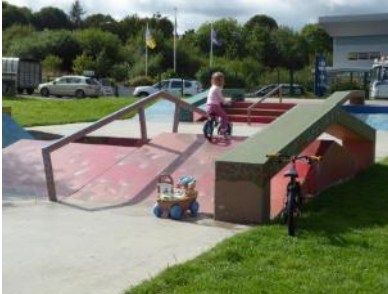
1.7	Children's play area and skate park	The children's play area and skate park are also excellent facilities with a wide range of equipment and several seating areas for adults. However, no wheelchair friendly equipment was noted or sensory activities which might suit specific needs of children with sensory and motor co-ordination challenges or the needs of children on the autistic spectrum

Community Parks and Playgrounds – Intergenerational Participation through Universal Design is a recent research report by the Centre of Excellence in Universal Design which should be referred to for an understanding of the complexity, challenges and benefits of providing fully inclusive play facilities. This should be considered in any future developments. Refer also to Greystones for inclusive children's play facility.	2

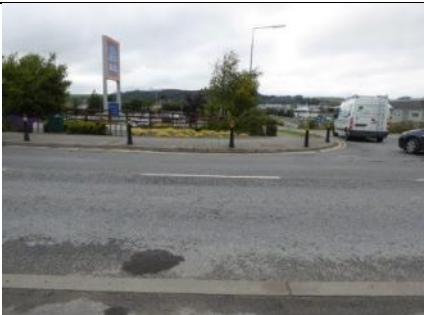
1.8	Corner of Oak Drive & N81	For pedestrians approaching from the north on the N81 there are no dropped kerbs /dished crossings on the east side of the N81 to permit level crossing to Oak Drive or from the Maxol Station to the footpath at Aldi.

Traffic Management Guidelines 2003 10.7 Dished crossings should be provided at locations where pedestrians will cross regardless of the provision of a pedestrian phase. ...(see Diagram 13.1)	1

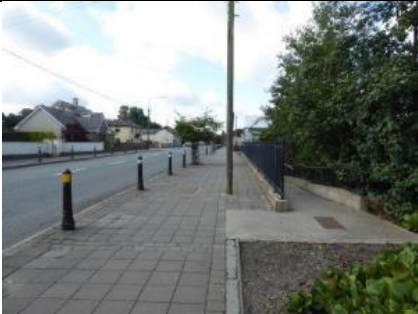
1.9	Ramp to Aldi	A telegraph pole at the top of the ramp leading to Aldi is located approx. 600mm from the inner edge of the path which could be hazardous to persons with vision impairments.

<p>TGDM 2010: 1.1.3.1 (d) street furniture, such as lighting columns, signposts, litter bins, seats, etc., should be located at or beyond the boundaries of the access route; BS 8300-1 8.2.2.1 Hazard protection within an access route Any feature which could constitute a hazard should wherever possible not project into or be located within an access route. However, if this is unavoidable, hazard protection should be provided</p>	3

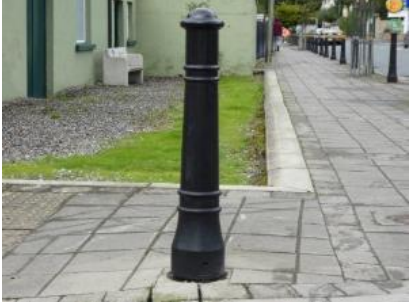
1.10	Bollards	Several black bollards through the town have no reflective bands at the top and are located where they restrict clear access and circulation.

<p>TGD-M:2010 1.1.3.1 General (e) low level posts e.g. bollards should not be located within an access route. Wherever bollards are provided they should contrast visually with their background (refer to 1.6.4)..... See also 1.13</p>

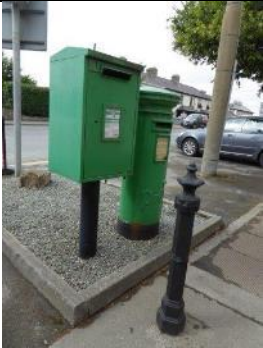
1.11	Post boxes	Post boxes have been located in inaccessible locations, impossible to reach by wheelchair users and with no tactile information for people who may be vision impaired as to their location

Ensure post box is accessible	3

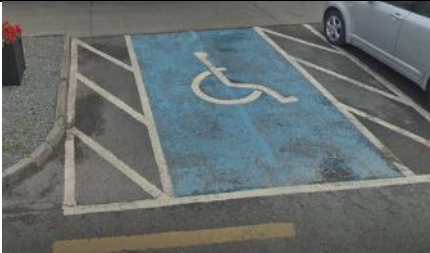
<p>1.16</p>	<p>Designated accessible parking bay opposite the flower shop</p>	<p>A designated bay diagonally opposite the flower shop has no rear access zone and substandard access zones both sides.</p>

<p>TGDM 2010:1.1.5 On Site Car Parking (d) the minimum dimensions of the designated parking bays should be in accordance with Diagrams 8 and 9; (e) A 1200 mm wide access zones should be provided on both sides and at the rear of each designated parking bay. The access zone at the rear of the parking bay should be clear of vehicular circulation routes. The access zone should contrast visually with the adjoining surfaces to ensure it is kept clear (refer to 1.6.4).</p>	<p>1</p>
-------------	---	--	--	---	----------

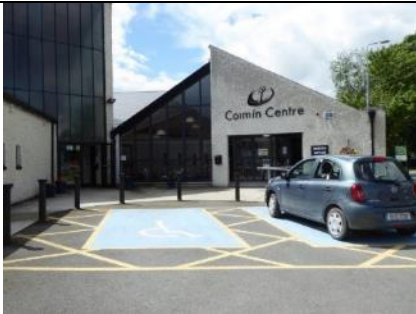
Ref.	Item / Location	Observation	Photo	Relevant Guidance/ Recommendation	Priority
2.1	Coimín Centre	There is a good example of designated accessible parking bays at the Coimín Centre which are clearly demarcated on the ground, with access zones to both sides and rear out of circulation routes. There is also good ramped and stepped access to the side.

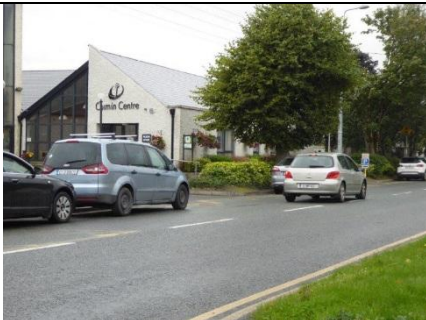
2.2	On street parking at St. Mary's school	At school collection time cars were noted at St. Mary's School backed up both sides of the road.

Accessible parking and set-down / pick up areas should be provided on street, if not provided off-street, and parking managed to ensure safety of all	1

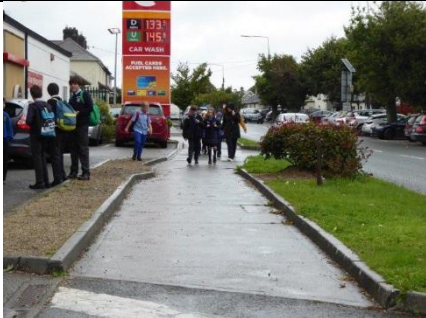
2.3	Route between St Mary's schools	Concern was expressed by a number of people about school children moving between the senior and junior schools at St Mary's. The route also passes by the entrance and exit to the Circle K filling station where children also use the shop.

Perhaps Circle K could be asked to erect signage alerting motorists to the presence of school children in this area as well as clearly visible road and footpath markings	1

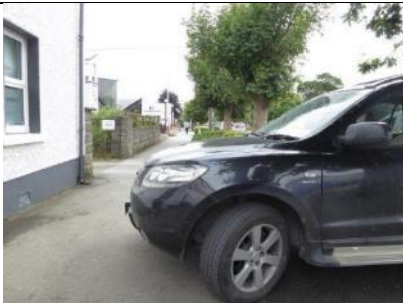
2.12	SuperValu to Murphy's Pub	The absence of a kerb and sub-standard head-on / perpendicular parking on the east of Main Street between SuperValu and Murphy's results in vehicles over-sailing the footpath. In other areas there are open drainage channels in the parking bays. Oversailing of footpaths occurs in numerous locations.

<p>Where the bays are of sufficient depth kerbs and wheel stops should be provided to prevent over sailing of the paths. If the bays are too short then parallel parking should be considered.</p> <p>TGDM 2010: 1.1.3.1 General</p> <p>(h) drainage gratings should be positioned beyond the boundaries of the access route. Where this is not feasible they should be flush with the surrounding surface.</p> <p>(i) dished channels should not be incorporated within an access route</p> <p>Rationale: They increase the risk of tripping; This would apply to where drainage channels cross the transfer space to the side of a designated bay</p>	1

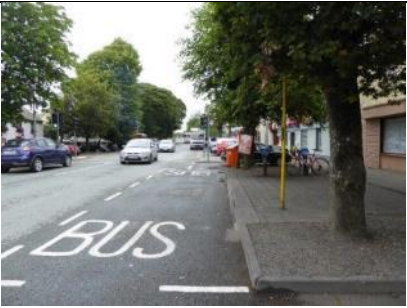
2.14	Footpath surfaces	Footpath surfaces in the vicinity of Hair Creations and Reid's pub are very uneven		Make good uneven surfaces	1
2.15	Bus Stop at Boyle Sports	The bus stop on the east of Main Street near Boyle Sport is not clearly visible due to overhanging trees, it has no shelter or seat, and lighting at night-time may be poor. Information about routes and timetables is not fully accessible. Whilst one stop on the west side of the street has a shelter there are none on the east side.

BS8300 2018:1 6.2.1 All Transport Modes Real-time information about routes and departures should be provided in both visible and audible formats (including assistive listening systems), both at stops and on the vehicle 6.2.4 Bus shelters	1

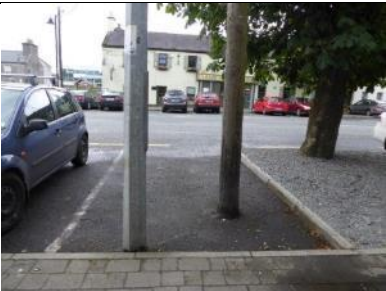
2.16	Obstructions in parking bays	Throughout the town there are numerous examples of obstructions in parking bays

These should be highlighted by reflective and contrast markings and relocated if necessary as part of an overall infrastructure upgrade	3

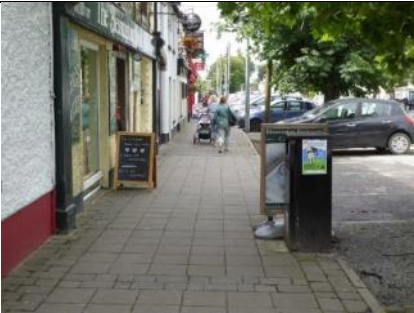
2.17	Sandwich boards	Sandwich Boards, litter bins, private bins and street furniture are inconsistently located throughout the town on both sides of the footpath, restricting access and making the footpaths difficult for people to negotiate, particularly people with mobility or vision impairments

BS 8300-1: 2018 A.1.7 "A" board signs are a particular problem, as being movable low-level signs they can be hazardous obstacles for people who are blind or partially sighted and restrict the width of routes for wheel chair users and parents with prams, etc. Many could be replaced by signs on buildings. Where they are used they need to be restricted to the street furniture zone, highlighted by visual and ground surface contrast, and robustly positioned in place so they do not fall or get knocked over.	1

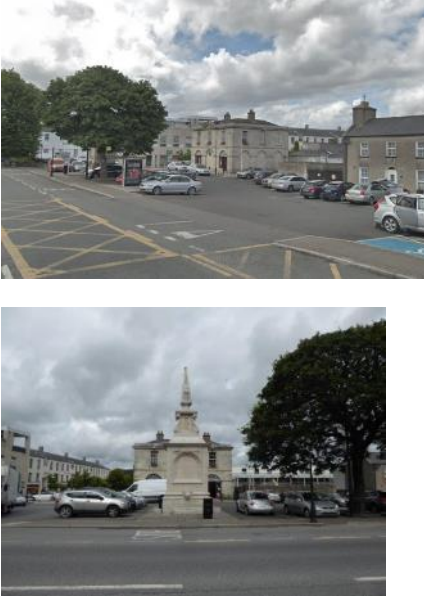
Ref.	Location	Observation	Photo	Relevant Guidance	Priority
3.1	Town Square	At the MarketSquare to the west of Main Street, there is no clear safe accessible route for pedestrians either from the east side of the street or in a north / south direction or leading to / from the square to the new shopping precinct and Dunnes Stores. There is confusion as to where there is pedestrian priority, whether part of the square is a shared space and where footpaths begin and end. The absence of dished kerbs in some areas and the proliferation of cars and other obstacles makes this area very difficult to negotiate for families, people with sensory or cognitive impairments and wheelchair users.

<p>Recommendations for this area need to be made in the context of a complete redesign.</p> <p>In the short term works are necessary to ensure that a) the accessible parking bays are large enough and with transfer zones in accordance with good practice b)there is at least one designated bay large enough to accommodate a mini-bus c) footpaths are continuous, wide enough and with dished crossings in sequence</p>	1

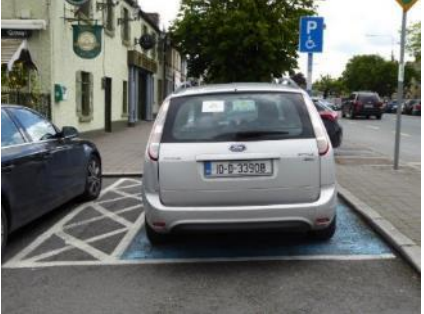
3.2	Designated Accessible Parking	There are six designated accessible car parking bays in the Market Square area, one at the West Wicklow House, one beside the public WC, one at the Ulster Bank, one on the opposite side of the road beside St Mary’s Church and two at McGreal’s Pharmacy. All bays are sub-standard either due to their size, their limited transfer space or absence of road markings. All are well signed on vertical poles.

<p>TGDM 2010:1.1.5 on Site Car Parking</p> <p>(d) the minimum dimensions of the designated parking bays should be in accordance with Diagrams 8 and 9;</p> <p>(e) A 1200 mm wide access zone should be provided on both sides and at the rear of each designated parking bay. The access zone at the rear of the parking bay should be clear of vehicular circulation routes. The access zone should contrast visually with the adjoining surfaces to ensure it is kept clear (refer to1.6.4).</p> <p>(g) all designated parking bays should be clearly marked on the ground with the symbol of access and, if necessary further signage should be provided</p>	1

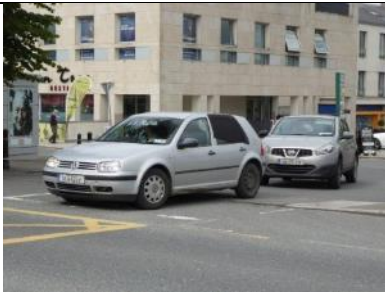
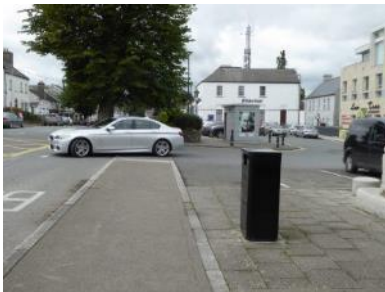
<p>(refer to 1.6.3);</p> <p>Diagram 8 Access around designated on-site perpendicular parking bay</p> <p>* Extract from the Traffic Signs Manual</p>	
3.3	Tactile Paving	<p>There is no tactile paving at the junctions of the main footpath and the carriageway. The brick footpath paving carries across the two junctions but it is unclear who has priority. The road markings appear to give vehicles priority hence tactile hazard warnings should be provided.</p>		<p>TGDM 2010:1.1.3.1 General (f) the danger of inadvertently walking into a vehicular route should be minimised by providing a separate pedestrian route. Otherwise, tactile paving should be used to provide warning and guidance for people with vision impairment (refer to 1.1.4);</p> <p>See 3.1 above</p>	1

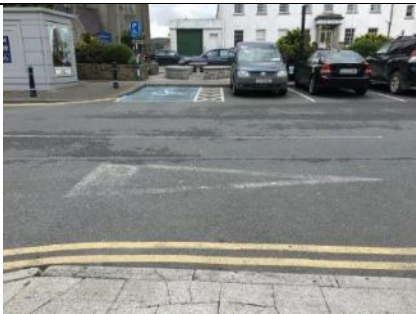
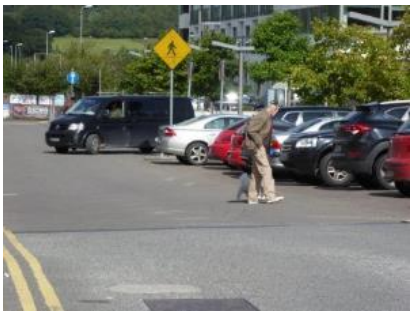
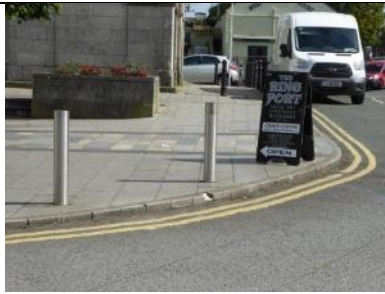
3.4	Dropped kerbs / footpath dishings	For buggies or wheelchair users the path dishings are inconsistent. In some areas eg. at the WC there is a dishing on one side of the road but not on the other. For example the footpath is dropped beside the accessible bay adjacent to the Public WC but is not dropped on the opposite beside the Lemon Tree or on the Credit Union side

`See 3.1 above	1

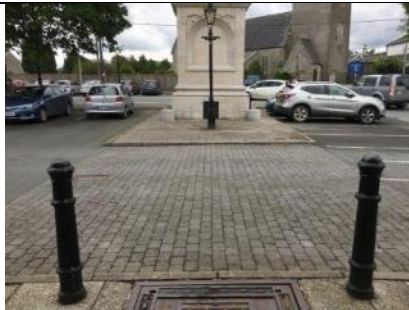
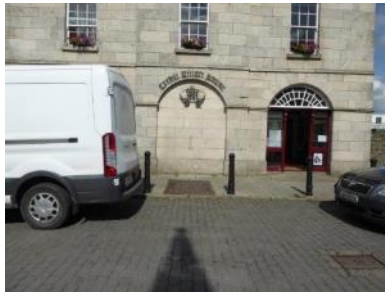
3.5	Raised table	There is a raised table (crossing) at the Credit Union (former Market House) leading to the monument but insufficient space either side of the monument to get past. If one remains on the path at the Credit Union there is then no access to the west side of Market Square in front of the old forge building.

See 3.1 above	1

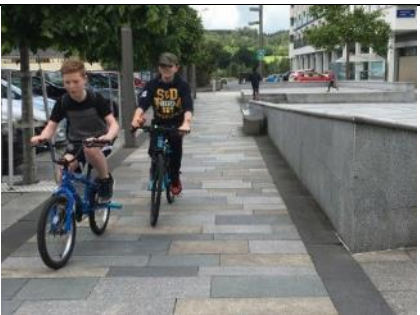
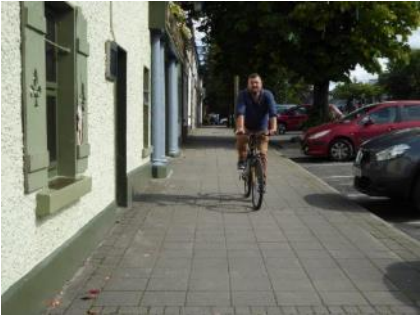
3.16	Cycle Paths	<p>There is no cycle path anywhere in the centre of the town and people with the result that both adults and children were found to cycle on the footpaths.</p>

<p>The provision of cycle paths is strongly recommended both to promote healthier lifestyles and reduce car dependency and also to cater for the many visitors and tourists who now visit by bicycle or who may wish to rent bicycles as part of the Greenway initiative.</p>	2

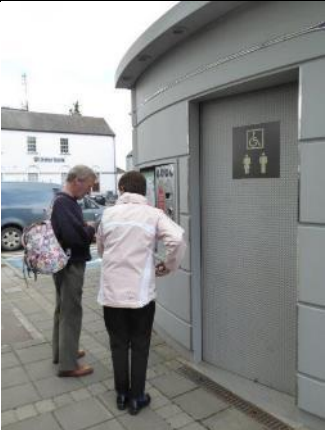
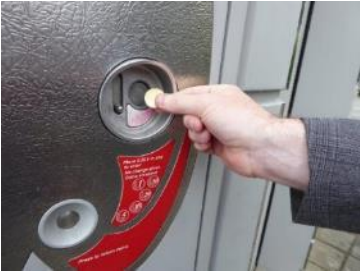
<p>3.17</p>	<p>Public WC</p>	<p>The automated WC was out of order twice during audit inspections and not inspected but visitors were noted struggling with the instructions which were hard to follow.</p> <p>There is no Accessible Change Facility in the town which would facilitate an adult or child with profound or multiple disabilities that needs a toilet facility</p>

<p>BS8300-1:2018 A.1.4 Signage Temporary signs and information are particularly important where facilities such aspublic toilets are temporarily out of service. In these cases signs need to be located at points where people can choose an alternative so that they do not have a wasted journey.</p> <p>Refer to Changing Places Ireland for Guidance on Accessible Change facilities or to BS 8300-2:2018.</p> <p>The provision of an Accessible Change Facility would be of great benefit for those who need one and its provision should be registered with Changing Places Ireland and highlighted when promoting Blessington as an inclusive tourist destination.</p>	<p>2</p>

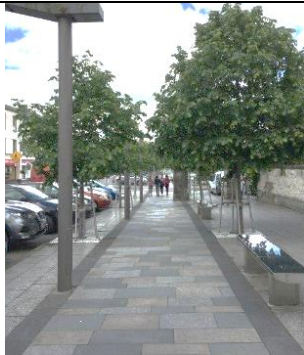
Ref.	Item / Location	Observation	Photo	Relevant Guidance / Recommendation	Priority
4.1	Paving	The new footpath to the north of the road leading to Dunnes Stores is paved with smooth stone flags and is defined by a dark band of paving both sides. Trees and street furniture are grouped within or outside this band. Whilst this keeps the accessible route clear and assists people who are partially sighted, for people who are blind there is no kerb or building line to follow. In wet conditions it was reported that this paving can become very slippy

This should be taken up with the management company responsible, the slip ratings established and remedial measures implemented as appropriate	2

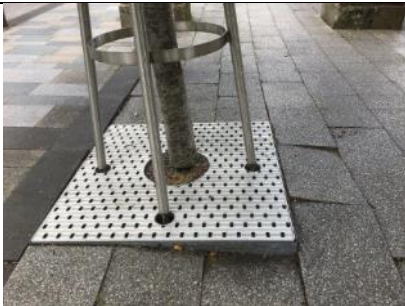
4.2	Hazards on paved areas	In places the flags and tree guards are lifting due to tree roots, creating trip hazards.

BS8300-1:2018 8.2.1.7 Tree grilles <i>COMMENTARY ON 8.2.1.7</i> Tree grilles can be particularly problematic for people using mobility aids such as sticks, canes, wheelchairs or wheeled walking frames, or for people with assistance dogs. Tree grilles should be avoided. Smooth or paved permeable surfaces should be used wherever practicable.	1

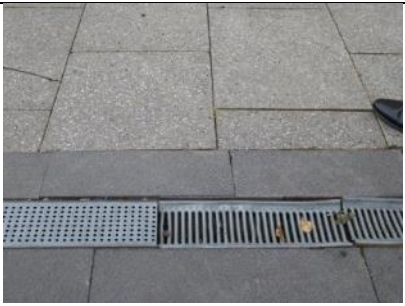
4.3	Drainage Channels	On the south side of road leading to Dunnes there are numerous locations on the footpath where light weight galvanised drainage channel covers have bent or lifted also creating trip hazards.

TGDM 2010: 1.1.3.1 General (h) drainage gratings should be positioned beyond the boundaries of the access route. Where this is not feasible they should be flush with the surrounding surface. Rationale: It is important to minimise the risk of trapping canes or wheelchair wheels;	2

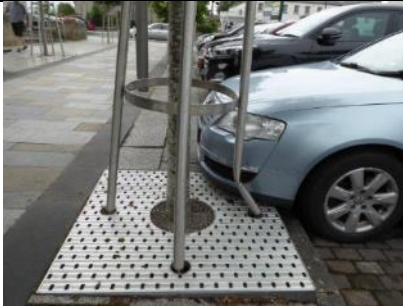
4.4	Tree Guards & Grilles	Tree guards have been damaged by parked cars

The location of trees and tree guards needs to be considered in the context of an overall upgrade of the urban environment	3

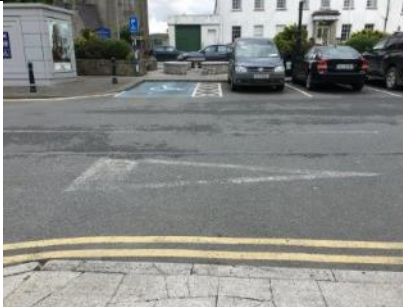
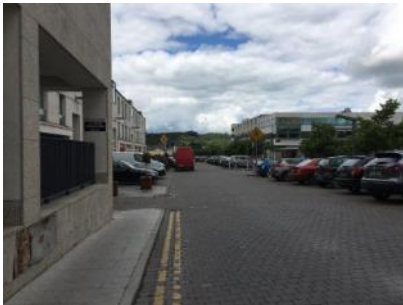
4.5	Paving, routes and dropped kerbs at the Lemon Tree corner	<p>New paving around the Lemon Tree is cracked and uneven. When approaching from the southern end of Market Square eg the Ulster Bank end, there is no means for a wheelchair user to cross the road to the opposite side or to reach any of the commercial units to the south of the new centre without travelling significant distances to cross the road. Similarly a wheelchair user arriving at this point cannot cross to the Public WC Convenience due to the absence of a dropped kerb.</p> <p>To the side of the building the path along the roadway is too narrow at only 1m wide for people to pass either wheelchairs or buggies and the covered walkway terminates in a flight of steps.</p>

See 3.1 above	1

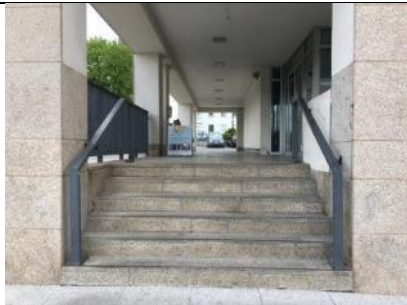
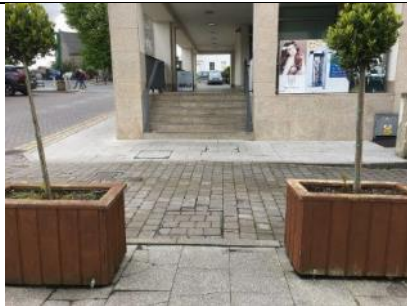
help people with vision impairment appreciate the extent of the stair and identify the individual treads;	
4.7	Unmarked crossing opposite the steps	When approaching from the west there is an unmarked crossing with cracked and uneven paving. For wheelchair users once one reaches the opposite side one has to proceed on the carriageway due to the steps and the narrow footpath to the left.

BS8300-1:2018 8.1 Access routes <i>...Street furniture, flower tubs, litter bins and signposts are all intended to improve the environment but, whether free-standing or projecting from a building, they are hazardous if not carefully designed and positioned.</i>	2
