**Street Route Accessibility Audit
For
Blessington & District Forum**

September 2019

Accessibility Audit

BLESSINGTON MAIN STREET, CO WICKLOW

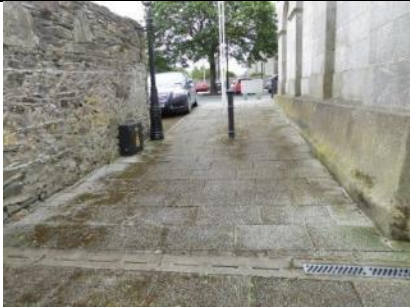
3.6	Ramped Route	To the north side of the Credit Union / Market House there is an unsigned access route to the lower level where the former tourist office and current craft centre is located. This route is at a gradient of between 1:13 and 1:15, equivalent to a ramp, but without any support or handrails. People arriving at the top of the steps on the southern side of the Credit Union Building are	 	TGDM 2010 1.1.3.4 Ramped access routes (g) the ramped access route may form part of a wider ramped area. The intended ramped access route(s) should be clearly identified and signposted where necessary (refer to 1.6.3). Additional handrails should be used to divide any intended ramped access route in to channels of	3

<p>not necessarily aware that there is a ramped access route on the other side and this should perhaps be signposted</p>

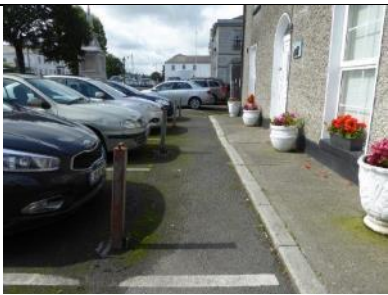
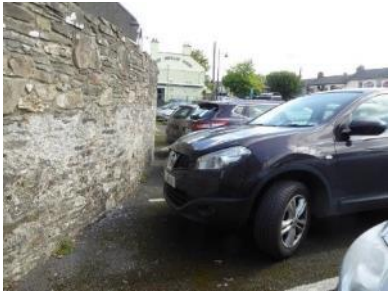
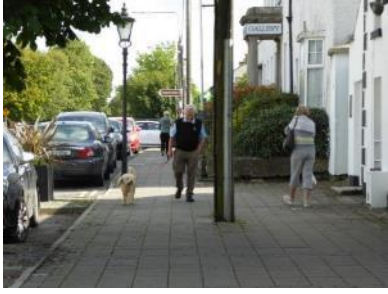
<p>unobstructed width not less than 1200 mm and not greater than 2500 mm. Rationale: This permits a person with less strength on one side to be within easy reach of support;</p>	
<p>3.7</p>	<p>West of Market Square</p>	<p>A narrow footpath runs along part of the West side of the Square which is too narrow for pedestrians and wheelchair users can't get on or off it in front of the Lemon Tree. A clear space has been created on the roadway by the introduction of bollards in front of the West Wicklow House and the Old Forge but it does not lead to another footpath.</p>

<p>Where shared surfaces are envisaged in any redesign great care should be taken to ensure that stringent guidelines are followed as the use of shared surfaces is controversial and not liked by many people with vision and hearing impairments, older people and people with children</p> <p>See 3.1 above</p>

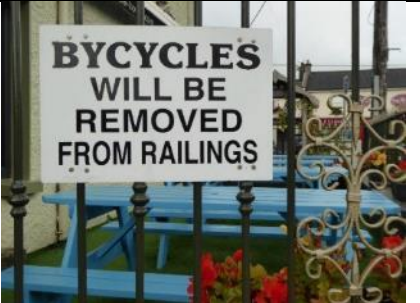
3.15	Cycle Routes & Parking	<p>There is no standard or non-standard cycle parking in either the Market Square or on the route to Dunnes. The only two cycle stands seen in the Public Realm are located at the bus stop beside Boyle Sports. There is a clear need for provision for cyclists and in particular due to the increasing popularity of cycling, its importance for health and wellbeing and in the context of the proposed extension to the Greenway.</p>	   	<p>BS8300-1:2018 7.1 Cycle parking Cycle parking should be located in a clearly defined area. Cycle stands should contrast visually with the background against which they will be seen. Cycle stands should provide ground level detection for the extent of the stand, in the form of a tapping rail for people who are blind or partially sighted navigating using a white cane, with its underside not higher than 150 mm above ground level, or similar barrier. Where a number of cycle stands are provided, some of the cycle stands should be positioned to allow the parking of adapted cycles, which can be considerably larger than other cycles. This should be taken into account in the positioning of cycle stands clear of pedestrian route widths (see also 8.2.1.3).</p>	2

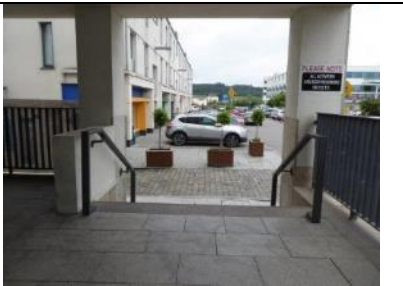
4.6	Steps	The step nosings at the end of the Lemon Tree building are poorly marked. There is a single row of corduroy hazard warning paving approximately 400mm deep instead of 800mm and the handrails do not extend past the bottom as would have been required by Building Regulations.

<p>TGDM2010: 1.1.3.5 Stepped Access Routes (h) all step nosings should incorporate a permanently contrasting continuous material on the tread. The material should be between 50 mm and 65mm wide on the tread and should contrast visually with the remainder of the tread (refer to 1.6.4).Rationale: This will</p>	2

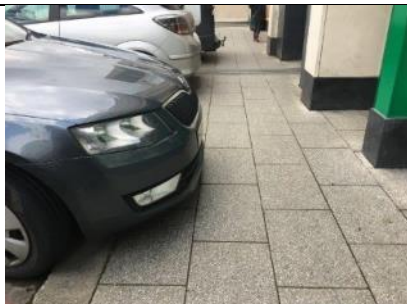
4.8	Path leading towards tourist office	The path on the south side of the road leading towards the tourist office is narrow with various obstacles and parked cars oversailing the kerb.

Improve parking as part of an overall parking and management strategy	2

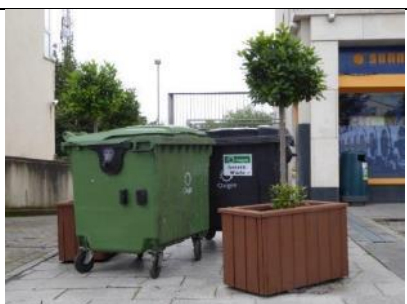
4.9	Eurobins and planters	Eurobins and planters were blocking the access route to the footpath leading to the commercial units and tourist office to the south of the new town centre

See 4.7	1

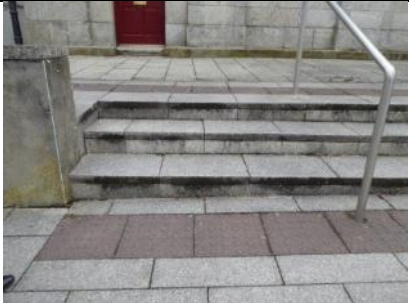
4.10	Steps to south side of Market House / Credit Union Building	The new steps to the south of the Market House have a single row of blister paving slabs 400mm deep at the top and bottom which can easily be stepped over and are not adequate to warn of a hazard. The nosings are also not highlighted.

TGDM2010: 1.1.3.5 Stepped Access Routes (h) all step nosings should incorporate a permanently contrasting continuous material on the tread. The material should be between 50 mm and 65mm wide on the tread and should contrast visually with the remainder of the tread (refer to 1.6.4).Rationale: This will help people with vision impairment appreciate the extent of the stair and identify the individual treads;	2

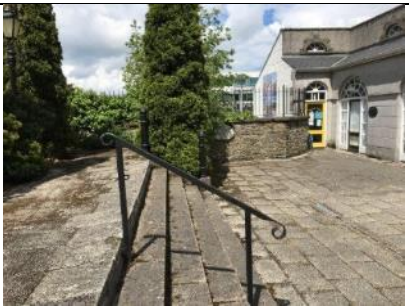
4.11	Steps to rear of Market House	The more historic wide flight of steps to the rear of Market House leading to the Craft Centre have a single central handrail.

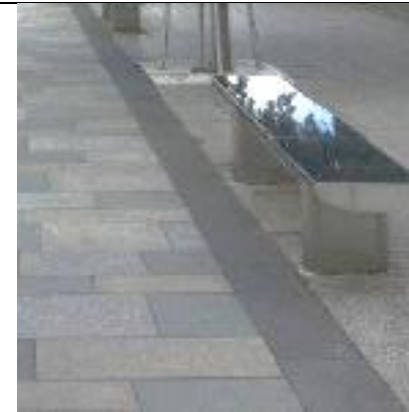
4.12	Bench Seating	Bench seating along the route towards Dunnes is helpful but it has neither arm nor back rests and is finished with a shiny polished surface.

BS 8300 2018:1 10.7 SeatingA choice of seating options should be provided suitable for a variety of users.... a) Where more than one seat...., a variety of seat heights should be provided..... b) For some seats, back support and arm rests should be provided Seating should contrast with the background against which it is seen. It should not have a highly reflective finish.	3

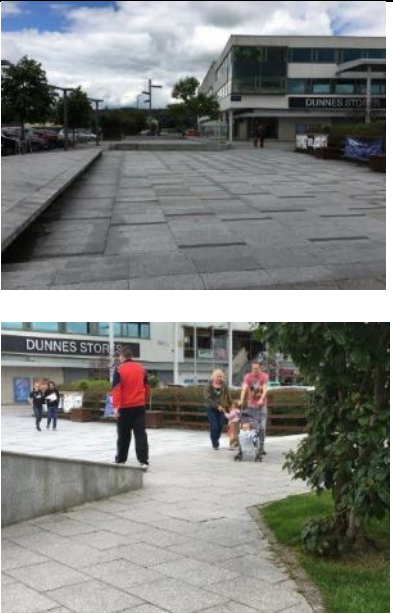
4.13	Plaza at Dunnes	<p>The hard landscaped plaza on the route to Dunnes appears well used by children playing, on trikes, bikes and skateboards. It seems like a missed opportunity not to have provided comfortable seating where older people could sit and watch or even exercise opportunities for older people.</p>

<p>BS8300-1:2018 10.7 Seating <i>Seating can be essential for people in terms of providing somewhere to stop and rest, but can also be a valuable tool in creating a place or space which is welcoming and inviting in which people will choose to spend time.</i></p>	3

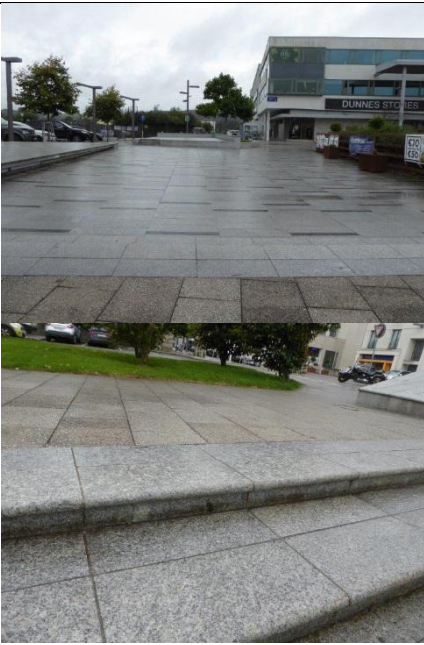
4.14	Plaza at Dunnes	<p>When approaching the plaza from the east side there are two steps which are unmarked, very difficult to detect, and which have no handrails or tactile paving</p>

<p>As these are on an important access route but located in an area that may be privately managed the issue should be raised as a priority with those responsible</p>	1

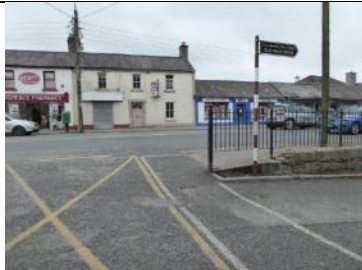
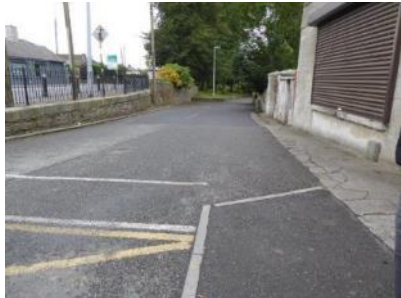
Ref.	Item / Location	Observation	Photo	Relevant Guidance / Recommendation	Priority
6.1	Ramped Path to side of the Old Naas Road	At the end the Old Naas Road there is a steep ramp at a gradient of between 1:7 and 1:8 between the path and the roadway / access route to the path outside Dempsey's with an equally difficult cross-fall at the intersection

TGD M 2010: Max ramp gradient is 1:12 on accessible routes, with handrail support. Consider redesign of entire corner	2
6.2	St Joseph's Hall	Access to St. Joseph's Hall is also very difficult due to the steep gradient but is within the private realm so was not considered

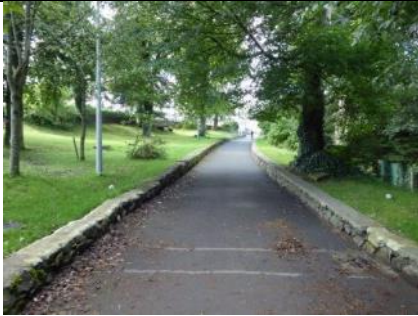
6.3	Dempsey's Lane	The pleasant walking route through the trees between Dempsey's and the Punchestown Road could possibly be exploited more for its amenity value

Consider providing seating in a sunny area and possibly some exercise equipment	3

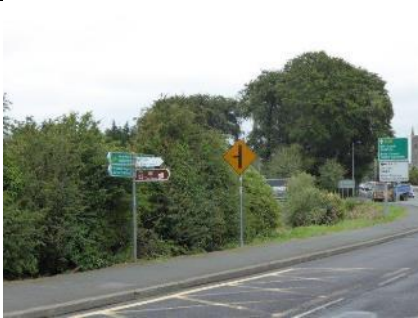
6.4	Punchestown / Naas Road junction	At the turn to the Naas Road the kerb dishing on the Blessington side of the junction is extremely steep with a gradient of between 1:4 and 1:8.

Improve gradient	2

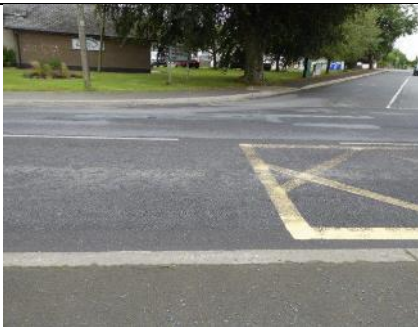
6.6	Troopersfield junction	The crossings on the Troopersfield road are good but there is no crossing when approaching from the west side of the main road.

Provide crossing point with dished kerbs and tactile paving	1

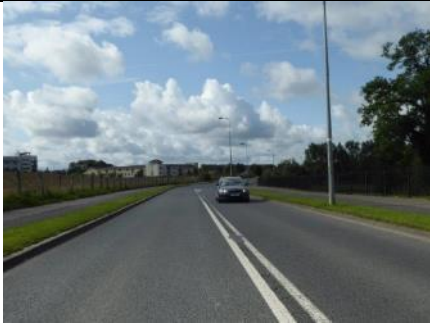
7.3	Relief Road	Traffic on the partially complete inner relief road appeared to be light at almost all times and there was no signage to indicate this could be a route for some through traffic

Consider if it is possible in the short term to divert through traffic away from the Main Street from Aldi via Oak Drive and back on to the N 81 at the Naas Road junction.	2

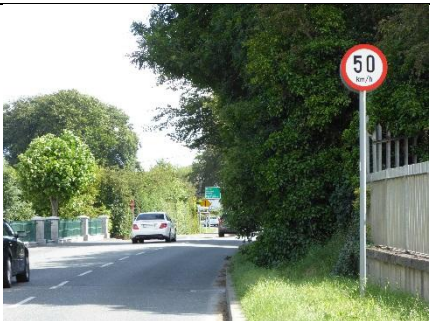
7.4	Speed Limit	The existing speed limit of 50km per hour through the centre of the town is excessive, particularly considering the width of the road, the numbers crossing, schools, elderly people and the historic environment. 5 out of 10 pedestrians hit by a car travelling at 50km/hr will die as opposed to 1 out of 10 hit by a car travelling at 30km/hr. (DMURS)

Local Authorities have powers to impose special speed limits of 30km/hour in designated areas eg in built-up areas and around schools. Consideration should be given to this as a possible short term measure until traffic calming and other measures are in place.	2
